Service Sheets for the **Norton** **Commando**

SERVICE RELEASE

I N D E X

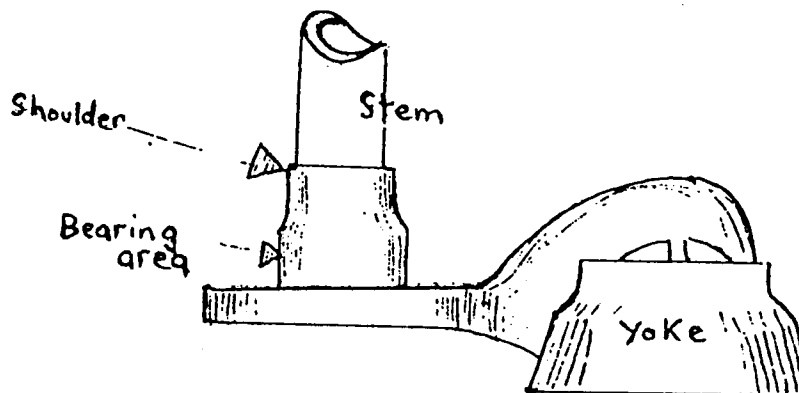
EXPLANATION: During assembly of the fork lower lug and stem to the steering head tube of the frame, it is possible for the shoulder of the stem to become lodged against the lower headrace. If this is not realised and the fork should turn on to full lock, the thick cross section of the yoke will lodge against the lock stop on the frame. As the stem is drawn home into the bearings by tightening of the large stem nut, the yoke cannot follow and will either be distorted beyond further use or fractured in the area where the stem joins the yoke.

ACTION: To prevent damage, ensure that the correct lower portion of the stem is central in relation to the lower bearing inner race before the stem nut is tightened.

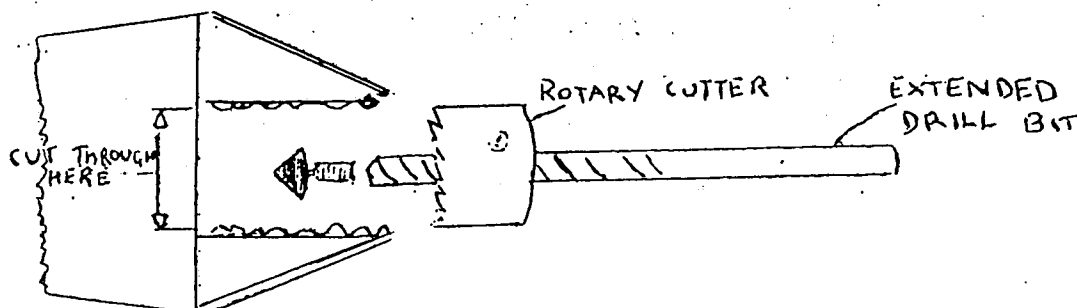
EXPLANATION: We are advised of sales resistance to machines fitted with the latest reverse cone silencers with perforated tubes in the end cones due to a whistling effect over subdued exhaust note.

ACTION: Using a 13/16" diameter sheet metal rotary cutter on an extended drill bit cut a hole through the blanking plate as shown below.

This modification makes it essential to change the main jets to 210 and to drop the needle in the clip to the top (No.1) groove. If carburation is not corrected after this silencer modification, severe damage will be caused. Observe that the resultant exhaust note still falls within legal requirements.

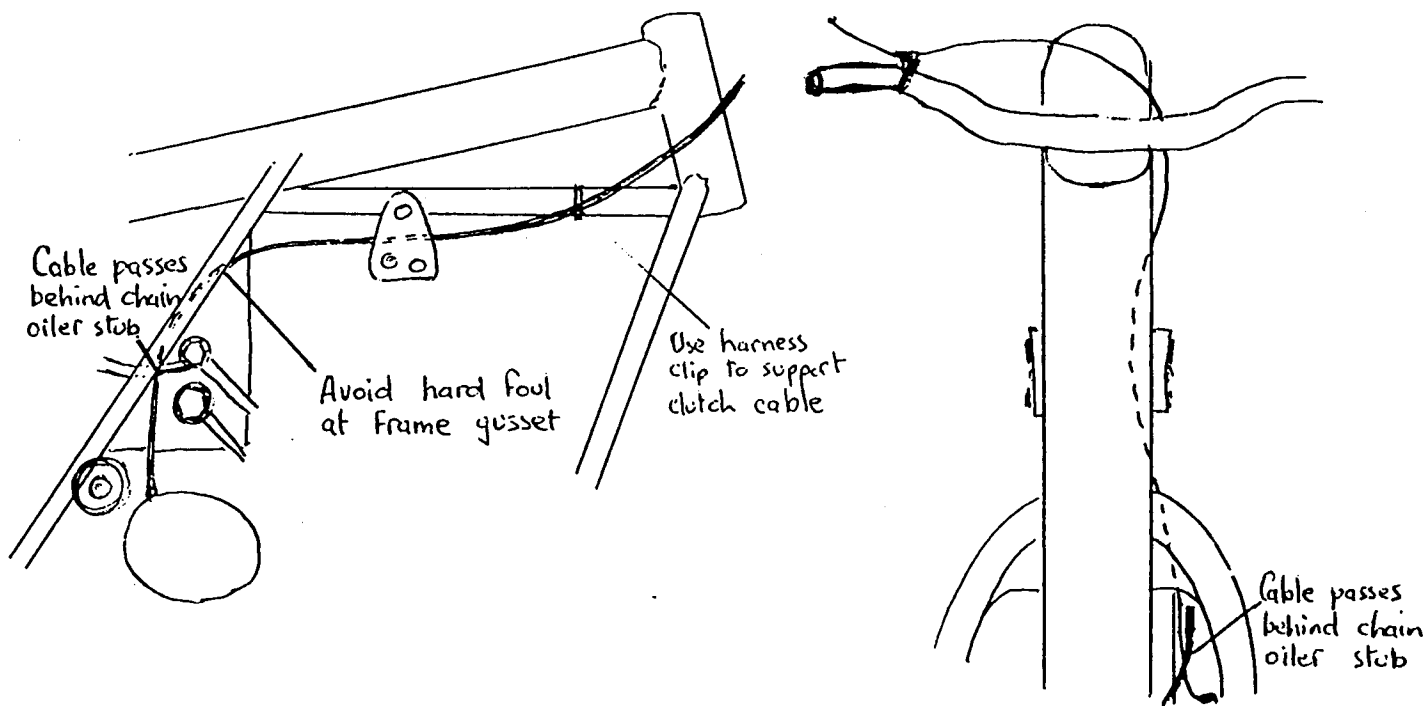
EXPLANATION: Due to incorrect routing of the clutch cable there have been certain complaints of a stiff clutch action. This is not due to any shortcoming in either the clutch or clutch thrust mechanism but is purely attributable to the run of the cable.

ACTION: Note the diagram below and re-route the clutch cable in accordance with this to eliminate any tight bends. On completion, run a little thin oil down the inner cable to ensure freedom of movement and the problem will be eliminated.

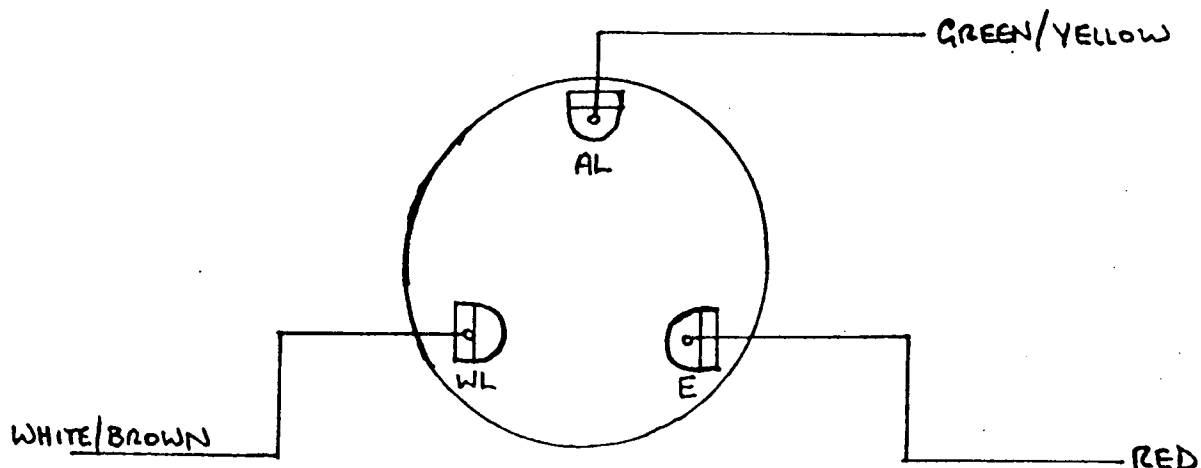
EXPLANATION: Instances have been reported of the charge warning light assimulator, being inoperative ie. the light has remained on when charging has been taking place. Investigation suggests that affected machines have had the leads to the assimulator connected incorrectly.

ACTION: Remove the fuel tank to gain access to the voltage assimulator connections. Ensure that the leads are connected as shown below.

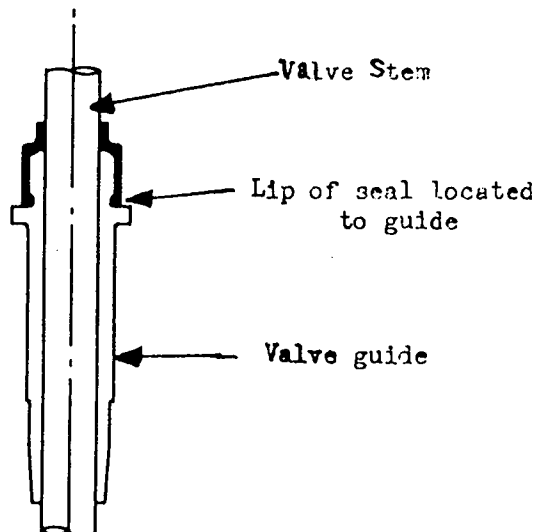
Service Release N45 detailed the introduction and fitting of new inlet valve guides with seals. We have subsequently encountered instances of the seals being fitted incorrectly.

It is most important for the lip of the seal to locate all round in the groove of the inlet valve guide. The illustration below shows the seal fitted correctly. If the lip is not located the seal will ride up and down with the valve stem rather than providing a wiping action to prevent oil passing between the valve and guide.

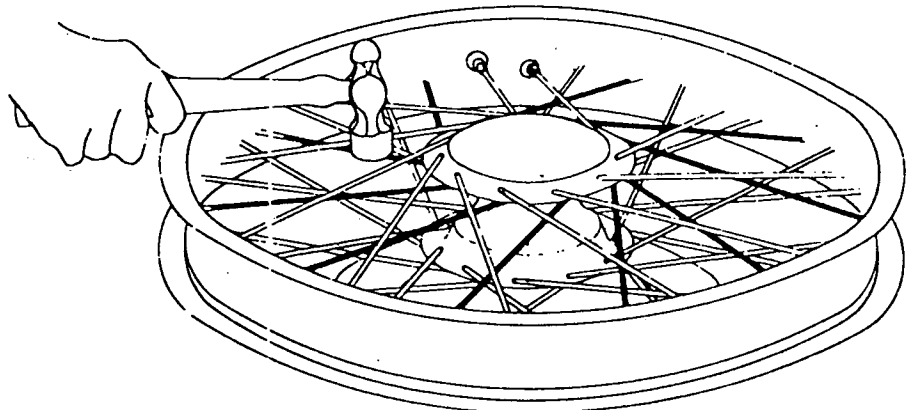
The spoking arrangement of the disc brake type of front wheel requires periodic attention to correct possible loss of spoke tension. To eliminate the need for regular attention, the following technique which is now applied to all disc brake wheels at the factory should be undertaken at the earliest opportunity (prior to delivery where possible):

- 1) With all spokes lightly tensioned, tighten left hand side inboard spokes.
- 2) Tighten left hand side outboard spokes.
- 3) As shown in the illustration below, set the left hand side inboard spokes straight (shaded heavily) by tapping the bowed portion of the spokes with a $\frac{1}{2}$ lb. (.225Kg) hammer and drift 3" (76.2mm) from the centre of the spoke head.

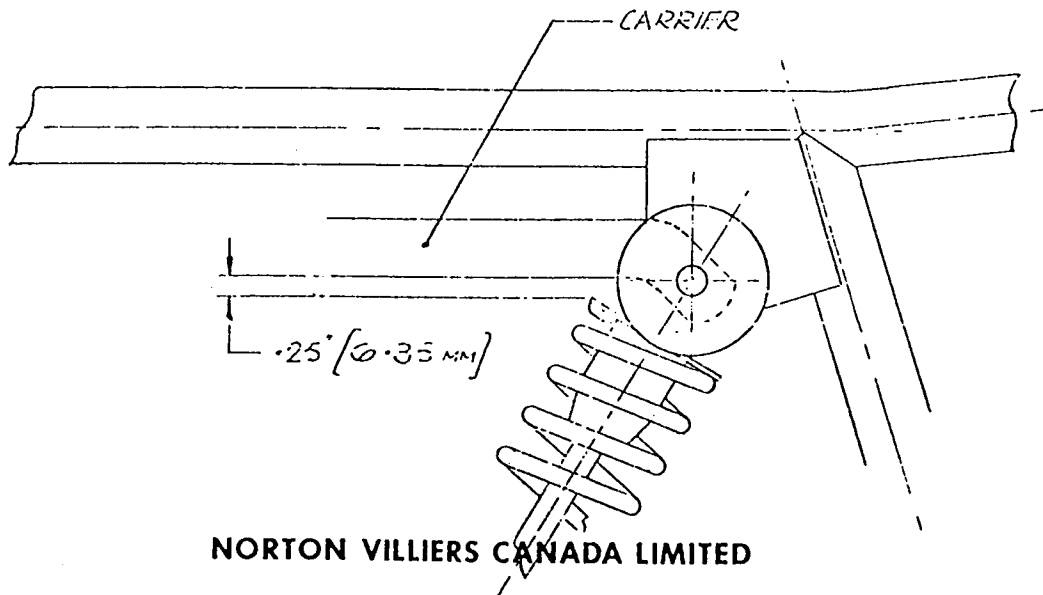
Only fit pannier equipment or rear carriers that are strongly and stiffly braced from both left and right support plates to a point approximately 12 inches (30cm minimum) rearwards from the dual seat knurled fixing nut. Unless the carrier frame is adequately braced, overload and distortion of the rear frame loop will inevitably occur.

Ensure the carrier frame loop that locates forward onto the suspension unit top bolt lies completely clear and free of the top fixing eye, and/or the top spring collar.
