Service Sheets for the **Norton** **Commando**

SERVICE RELEASE

I N D E X

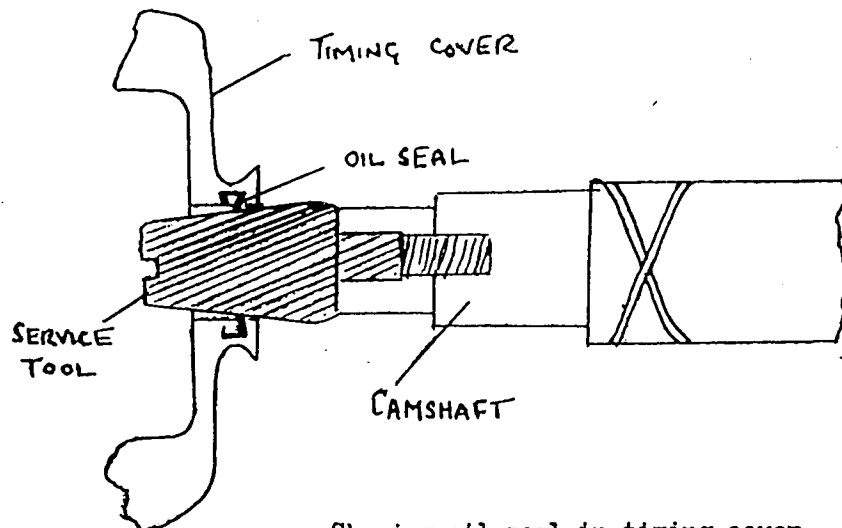
EXPLANATION: When the timing cover is offered over the end of the camshaft, the oil seal at the contact breaker housing must pass over the large diameter of the camshaft. This invariably causes damage to the pressure lip of the seal. A special tool is provided in the tool kit to screw into the end of the camshaft and guide the seal home without damage.

Showing oil seal in timing cover
being slid over guide onto camshaft.

ACTION: Screw the service tool into the end of the camshaft, finger tight, before the timing cover is offered up. Smear the tool taper with clean oil and push the cover gently into place so that the seal slides easily over the tool and onto the camshaft. The tool has a screwdriver slot and can be removed simply at this stage.
